## **Matthew Jones House: Recommendations for Treatment**

Edward G. FitzGerald

April 2016

Final report

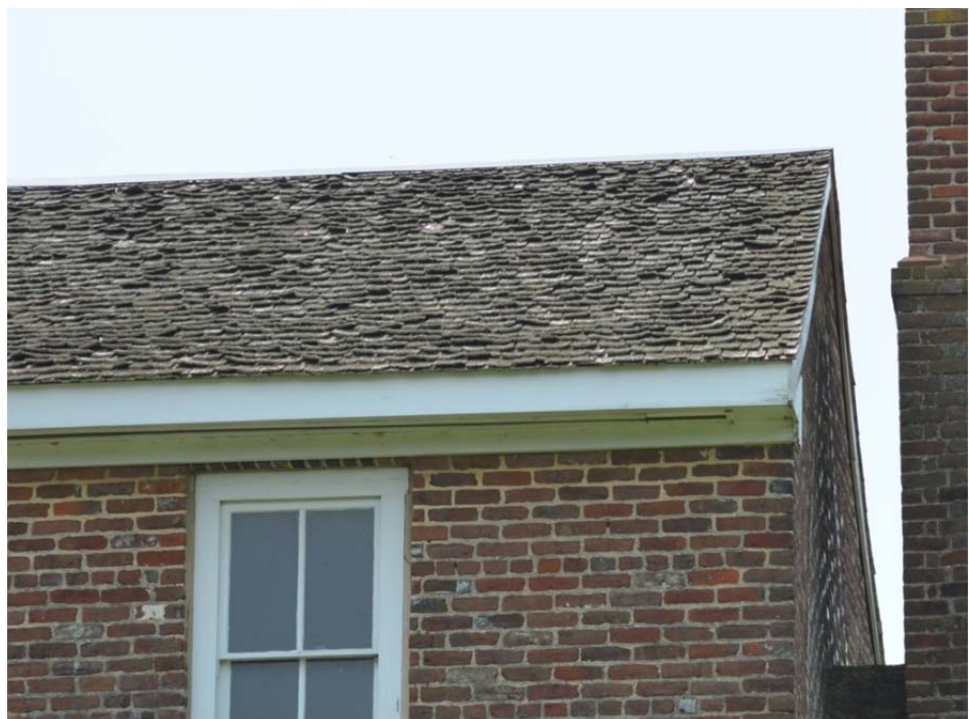
The existing shingles exhibit extensive deterioration and have reached the end of their useful life. Biological growth is present and extensive on the exterior. Mold growth on the interior may be attributed to roof leaks. Many of the oak shingles exhibit distortion (cupping along the width or curling along the length) or have split or shrunk, leaving gaps where insufficient offset exists and exposing the interior of the structure to the elements (Figure 3). While quarter-sawn oak shingles are known to have a life expectancy of up to 50 years, deterioration exhibited by the MJH roof (i.e. distorted and shrunk shingles) is also a known issue with this material. To some degree, deterioration in the roof covering can be attributed to normal “wear”. However, analyzing this wear can be informative and can aid in developing a plan for future work that addresses deficiencies and improves roof system life.

- Poor quality material - Some shingles may not be quarter-sawn as specified during the 1993 rehabilitation but rather, are flat-sawn, a cut more prone to warping. Newer growth timber and the prevalence of sapwood may also predispose the shingles to deterioration.

- Shingle size - Shingles 3 inches wide and smaller make it difficult to achieve sufficient offset from adjacent course joints (especially after shrinkage and cracking), predisposing the roof to leaks. Shingles cut to a greater thickness may better resist distortion.

- Sheathing size and spacing - The wide boards and narrow spacing may be limiting airflow and preventing adequate drying of the underside of shingles. Curling shingles, a condition apparent at the MJH, can occur when the rain-saturated wood begins to dry on the exposed topside while the underside remains wet.

- Improper installation - Shingles nailed too high on the shingle are more prone to curling. Shingles installed too tightly together are more prone to cupping and cracking.

**Figure 3. Northwest corner of main roof showing shingle distortion and biological growth. (NCPTT, 2015)**

1. Shingles should be replaced with a durable material that matches the existing material in appearance.
2. Because the original (c. 1893) shingle material is unknown, several options exist that may increase service life without detracting from historic character:

3. Minimum shingle width should be increased to 4 inches to ensure a 1½ inch gap offset from adjacent courses. 16 inch shingle length should be used to match existing. Minimum butt-end thickness should be increased to 5/8 inches.
4. Only 100% edge grain and 100% heartwood, clear of any defects should be permitted. Shingles should be either kiln or air dried to no less than equilibrium wood moisture content for the selected species and local conditions.<sup>11</sup>
5. Shingles should be installed with a 4½ inch exposure to match existing and nailed approximately 1½ inches above the exposure line. Type 316 stainless steel nails should be used. Copper nails must be used where nails penetrate flashing.

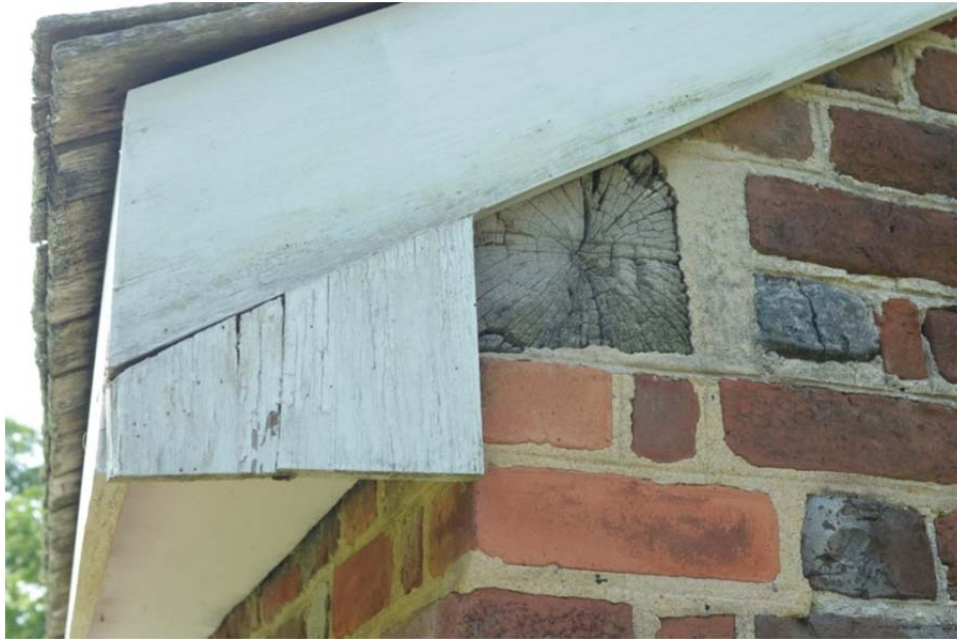
Soffits, fascia, frieze boards, and rake boards were not physically inspected except where easily accessible on the shed roof. These were observed to be largely sound, however, the east end of the fascia was found to be rotten (Figure 4). Paint loss, weathering, and minor warping are visible on the rake boards on all gable ends.

**Figure 4. Replacement fascia board at east corner of rear shed is rotten and requires replacement. (NCPTT, 2015)**

1. Sheathing should be inspected further to determine its condition and suitability for continued use.
2. Soffits, fascia, frieze boards, and rake boards should be inspected further to determine their condition and suitability for continued use. Existing coatings on these elements should be scraped and sanded back to bare wood and repainted using a high quality 3-coat 100% acrylic coating system (1 primer + 2 top-coat), tinted to match existing.

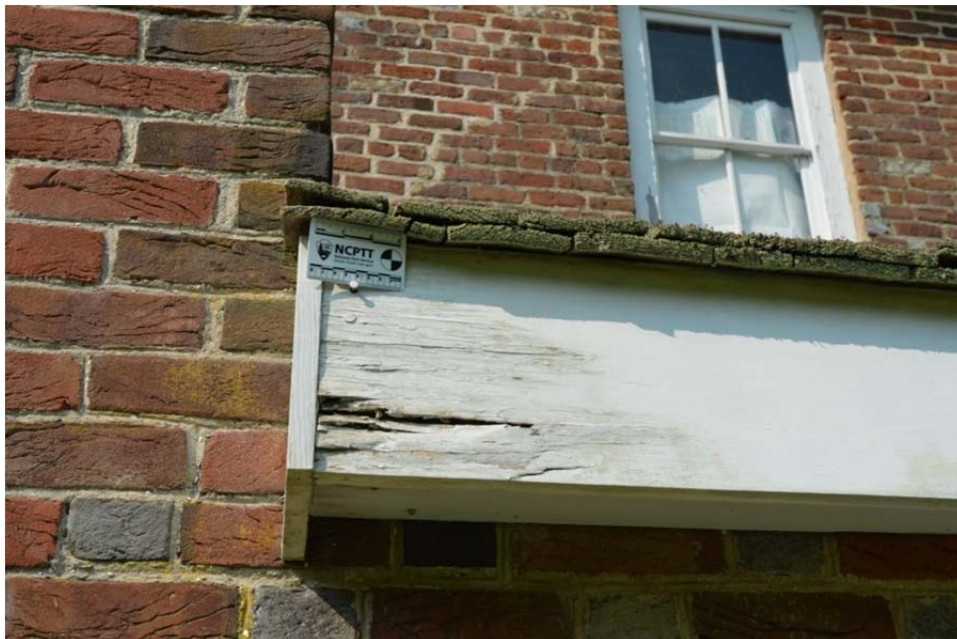
**Figure 5. Soffit end and exposed sill plate end at northwest elevation of rear shed. (NCPTT, 2015)**

A poor design detail related to the exterior trim work was found at the northwest corner of the rear shed. The soffit end board in this location stops at the wall line, leaving the end grain of the shed roof sill plate (dated to Period II, c. 1730) exposed to the elements (Figure 5). It is unclear whether this detail is historic or one added during rehabilitation work (the area is not covered by HABS documentation or available historic imagery).

3. The fascia end board at the northwest corner of the rear shed should be extended back along the rake board to cover the exposed rear shed sill plate end. Under no circumstances should this sill plate end be coated or otherwise sealed, as this will trap moisture in the wood and promote deterioration.

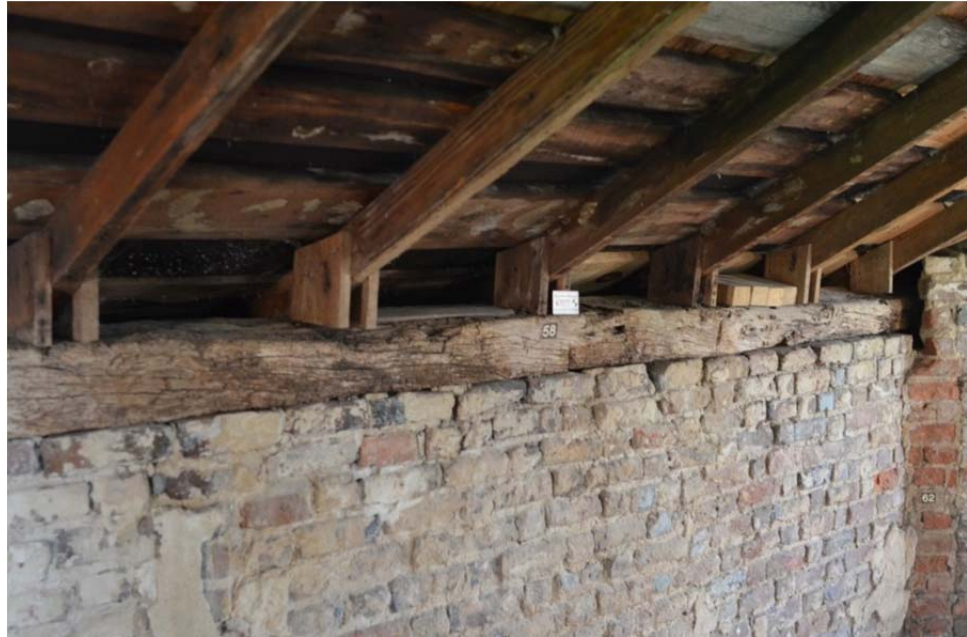
Roof sheathing was not physically inspected during the site visit, except where accessible from the ground floor in the rear chamber. Sheathing exhibits visible signs of water-related damage and should be inspected further to determine its condition and suitability for continued use (Figure 6).

**Figure 6. Exposed rafters and sheathing in rear chamber exhibiting signs of past and ongoing water damage. (NCPTT, 2015)**

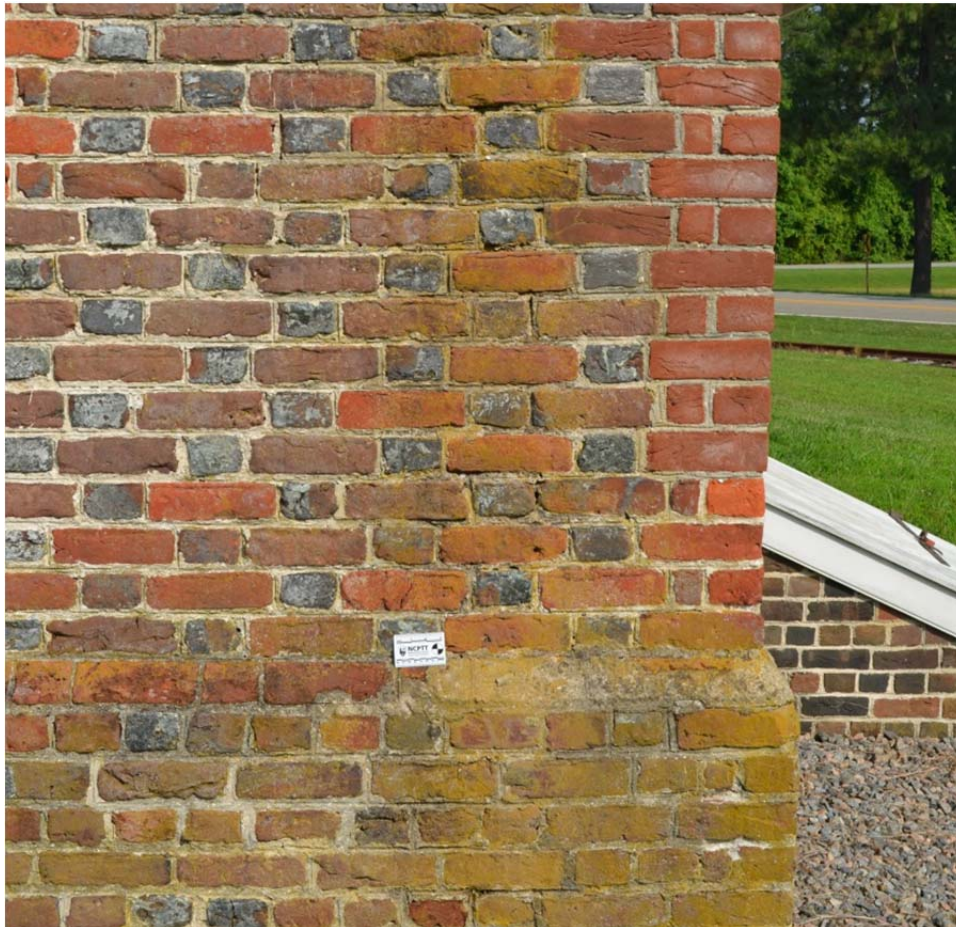
**Figure 7. Biological growth on southeast elevation resulting from rain water draining from the rear shed roof. (NCPTT, 2015)**

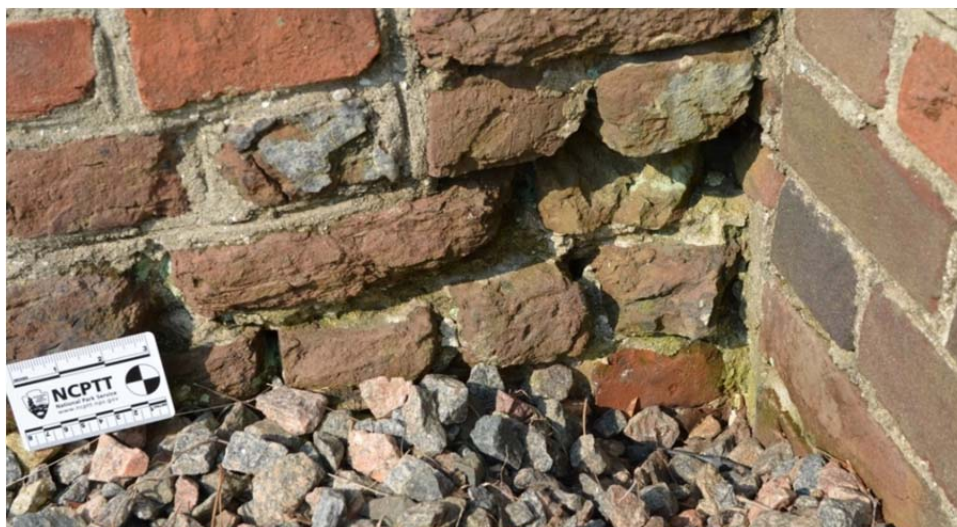
The base of the wall at the southeast tower-main block juncture has deteriorated to the extent that mortar is missing and bricks have dislodged from the wall (Figure 8). This deterioration is most likely due to a concentration of rain water that drains from the roof valley above and collects along the base of the wall because of a low spot in the site grading.

**Figure 8. Missing brick and mortar at the southeast tower-main block juncture. (NCPTT, 2015)**

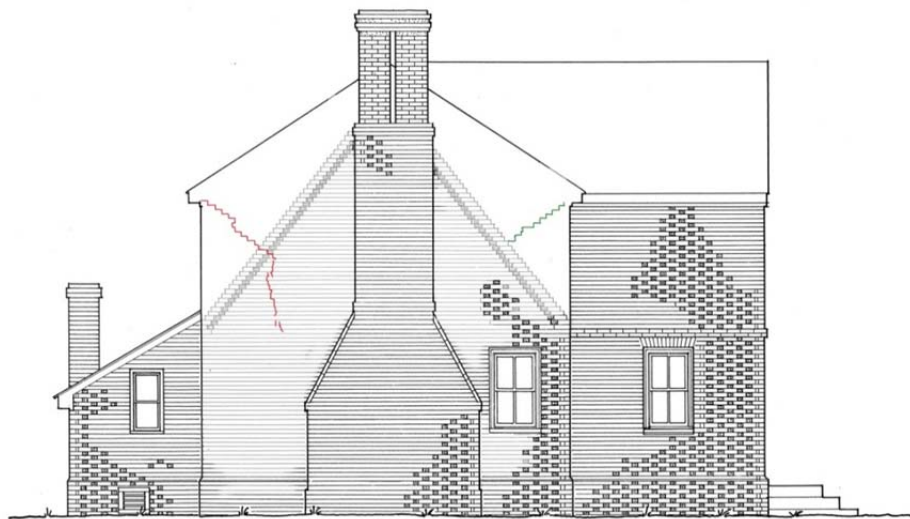
**Figure 9. Northwest elevation showing location of the active crack in red and an inactive repaired crack in green. (Modified from HABS, 1940)**

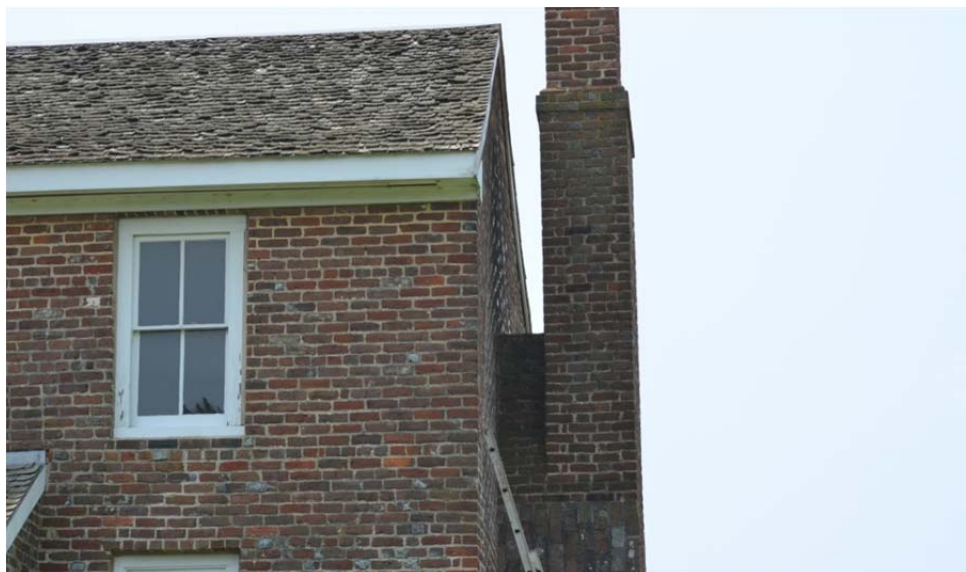
**Figure 10. Inward deflection of the northwest wall as seen from the northeast elevation. (NCPTT, 2015)**

This condition was present during the 1993 rehabilitation, when the crack in the Period III brickwork was filled-in with mortar. The crack has subsequently reopened and enlarged, indicating active structural movement. A second, apparently inactive transverse crack, mirrors the one to the north of the chimney on the south side of the wall. This crack was also filled in 1993 and does not appear to have reopened since then. Evidence indicates that movement of this wall was also an issue prior to the 1993 work. A photograph from the 1940 HABS documentation shows a filled-in crack in the Period II brickwork (Figure 11). However, the cracks in the Period III wall section do not seem to be present, suggesting that they developed in the 50 years following the documentation work.

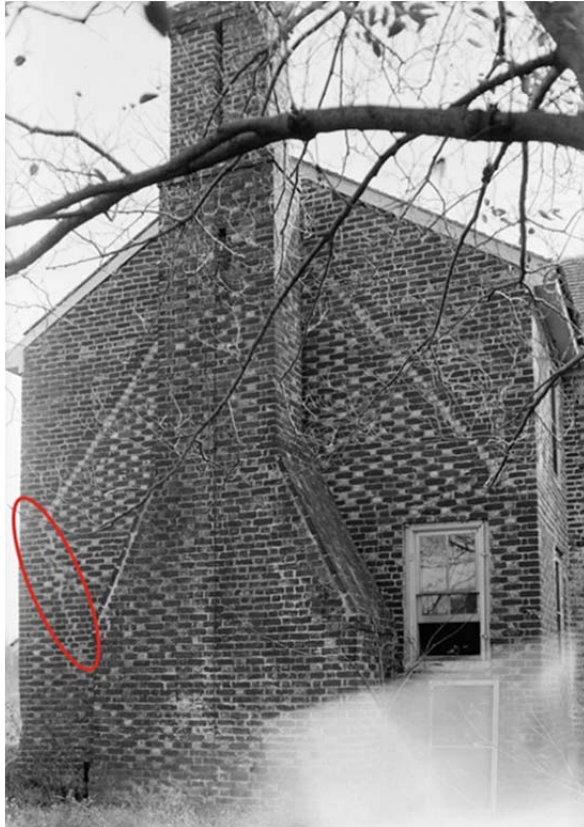
**Figure 11. 1940 Image of northwest elevation showing repaired crack circled in red. (Modified from HABS, c. 1935)**

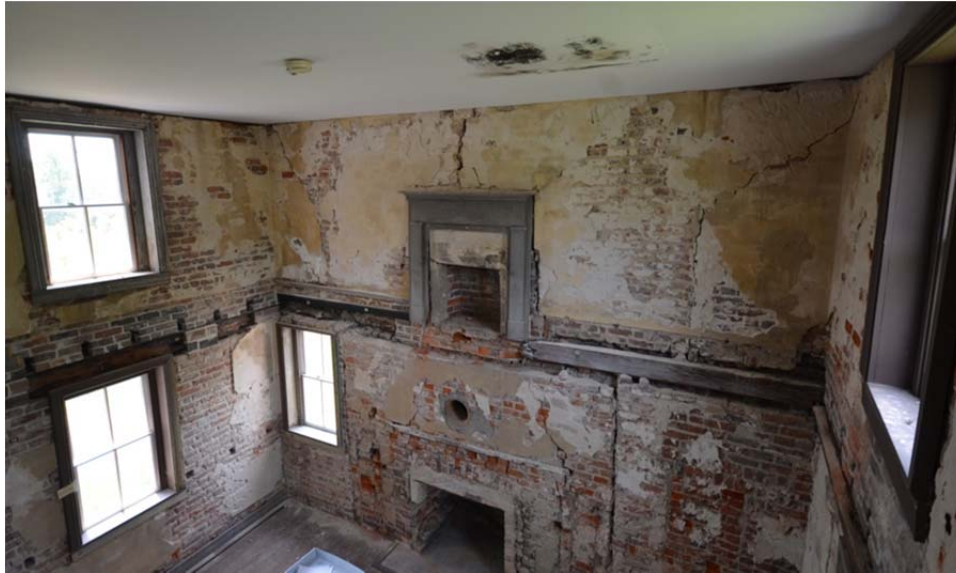
conditioning the space with the HVAC system. Moisture enters the soft and porous brick, mortar, and plaster, causing hygroscopic constituents of these materials (e.g. clays, uncarbonated lime, etc.) to swell. This hygroscopic expansion, followed periods of drying and contraction, gradually acts to break apart softer materials.

**Figure 12. Northwest interior elevation showing plaster in various states of deterioration. (NCPTT, 2015)**

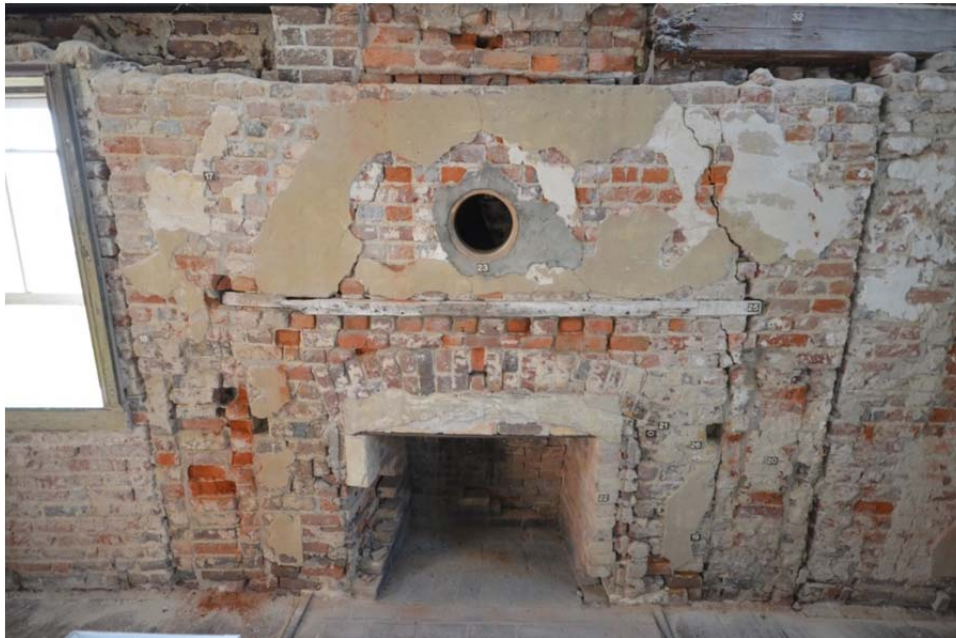
**Figure 13. Parlor fireplace (northwest elevation) and masonry abutments exhibiting loss of bricks, plaster, and mortar. (NCPTT, 2015)**

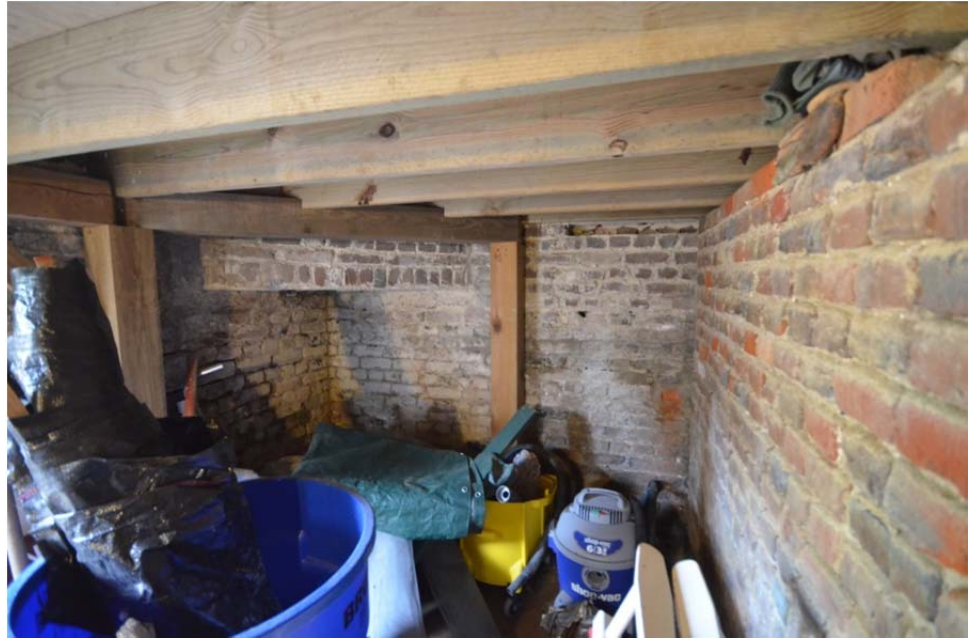
**Figure 14. Mortar joints on the east side of the wall that partitions the cellar antechamber and cellar exhibit extensive mortar deterioration and loss. (NCPTT, 2016)**

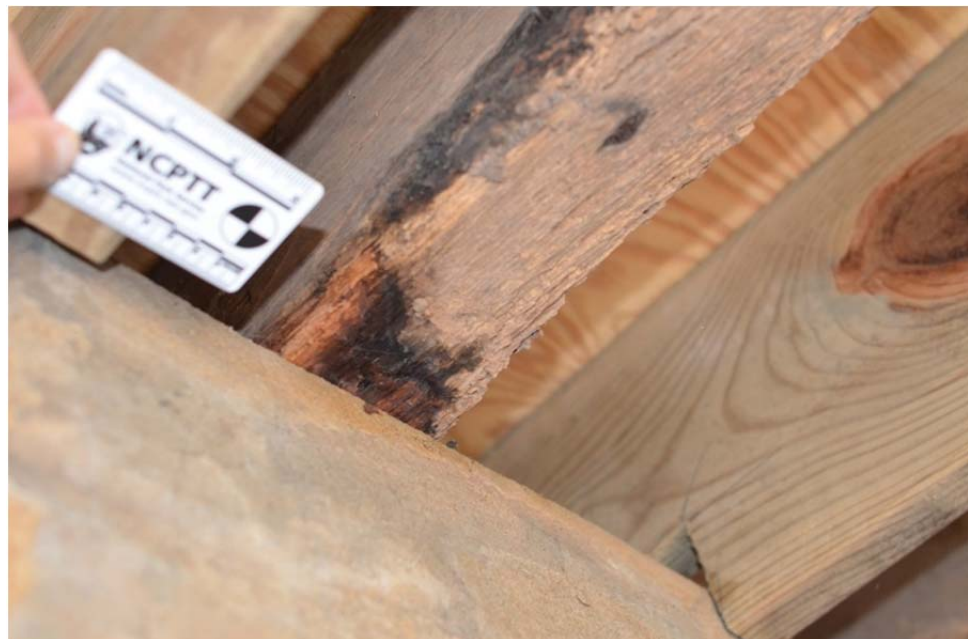
In addition to its impact on the masonry, rising damp in the cellar/foundation walls is adversely affecting structural framing components. Wood floor joists, many of which date to the 1993 work but some of which are original to the structure, were observed to be wet and actively rotting where they contact masonry (Figure 15). The steel structural support system, which rests on footings set into the concrete floor, exhibits active corrosion (Figure 16).

**Figure 15. A floor joist original to the rear shed rests directly on the west antechamber partition wall and exhibits active moisture-related rot as water wick up through the masonry into the wood. (NCPTT, 2016)**

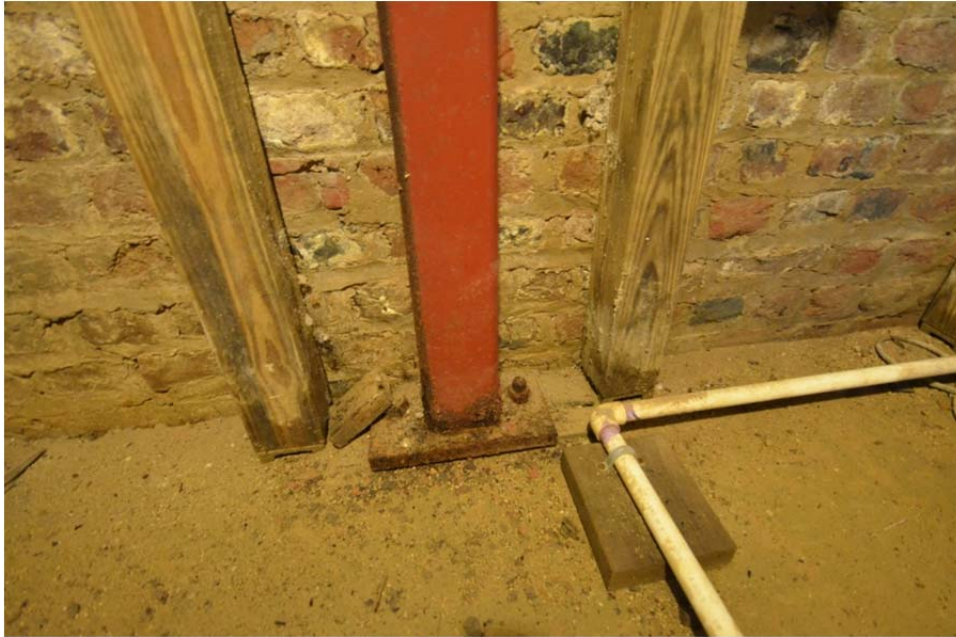
**Figure 16. Footing of steel structural support system exhibiting corrosion. (NCPPT, 2016)**

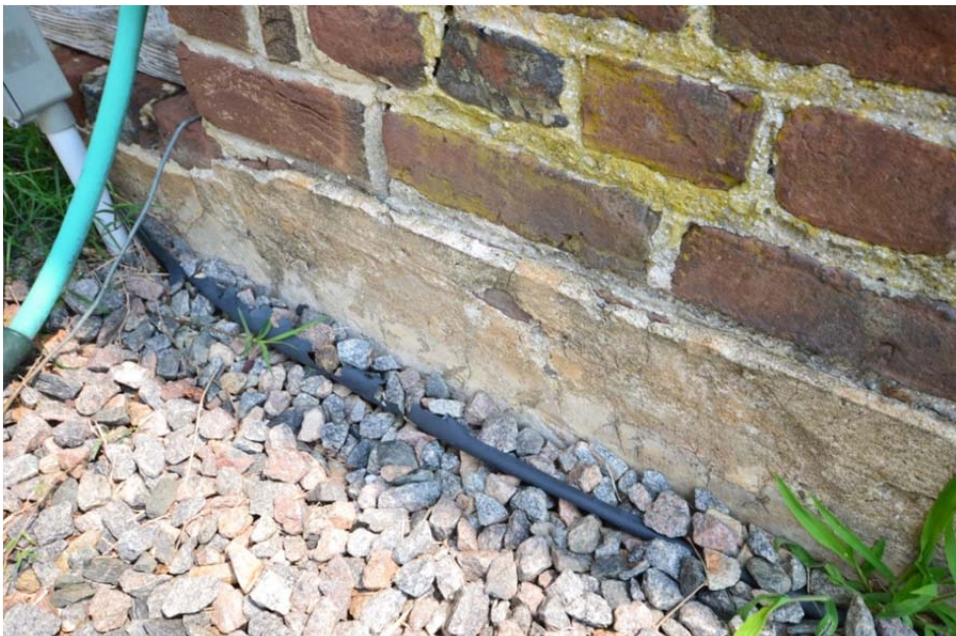
It is unclear whether the perimeter drainage system is functioning correctly. High moisture levels present in the foundation walls suggest that it is not performing as it should. In some areas, the polyethylene vapor barrier lining the trench was not in complete contact with the foundation walls (Figure 17). This condition could be channeling water down the foundation walls increasing their moisture content. Excavation and thorough inspection of the system will be necessary to assess its ability to transport water away from the site. In addition to this system, site drainage is affected by improper grading. Low grading sloping toward the foundation was observed in areas on all elevations and is particularly evident at southeast tower-main block juncture (near the southeast entry).

**Figure 17. Crushed stone from the perimeter drainage system has filled-in behind the polyethylene vapor barrier showing that it is not in contact with the foundation wall and can allow water to bypass the system. (NCPPT, 2015)**

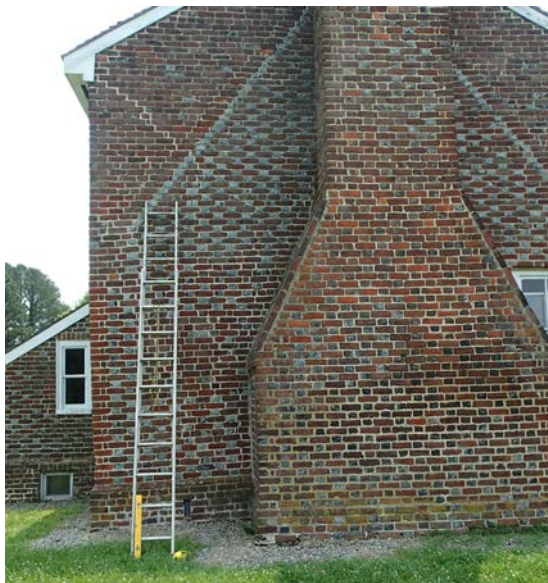
The Period II/III gable end wall is in the shape of an inverted U, and surrounds, but is not engaged with, the Period I chimney mass and fireplace opening. The Period II/III wall is weakened by the decay of the embedded Phase I timber top plate which extended from the mass of the fireplace to the corners of the building at the level of the Period I/II loft and Period III second floor. Above the line of the beam pocket, the Period II/III wall appears to be rotating inward about three axes – the two vertical axes at the exterior corners and the horizontal axis where the masonry section is weakened by the void for the no-longer extant/intact wall plate. The upper corners of the wall may also be rotating about the joint of the Phase II/III intersection. The corresponding exterior and interior crack patterns in the wall are more pronounced at the north end than the west end, possibly because the pocket for the wall plate on the west end was supplemented with steel reinforcement whereas the north end was not.

Matthew Jones House crack at Northwest

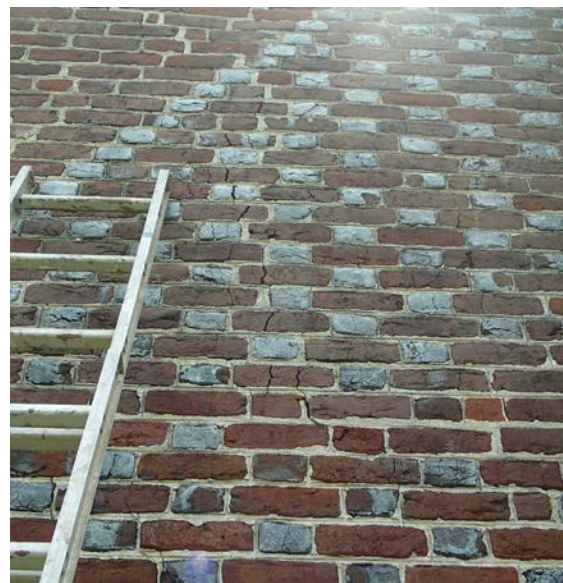
Matthew Jones House Crack Detail
